## 4.6 Geology and Soil

This section describes the geologic and seismic conditions within the Project area and evaluates the potential for geologic hazard impacts associated with implementation of the proposed Project. This section is based in part on the following reports included in the Appendix F to this EIR:

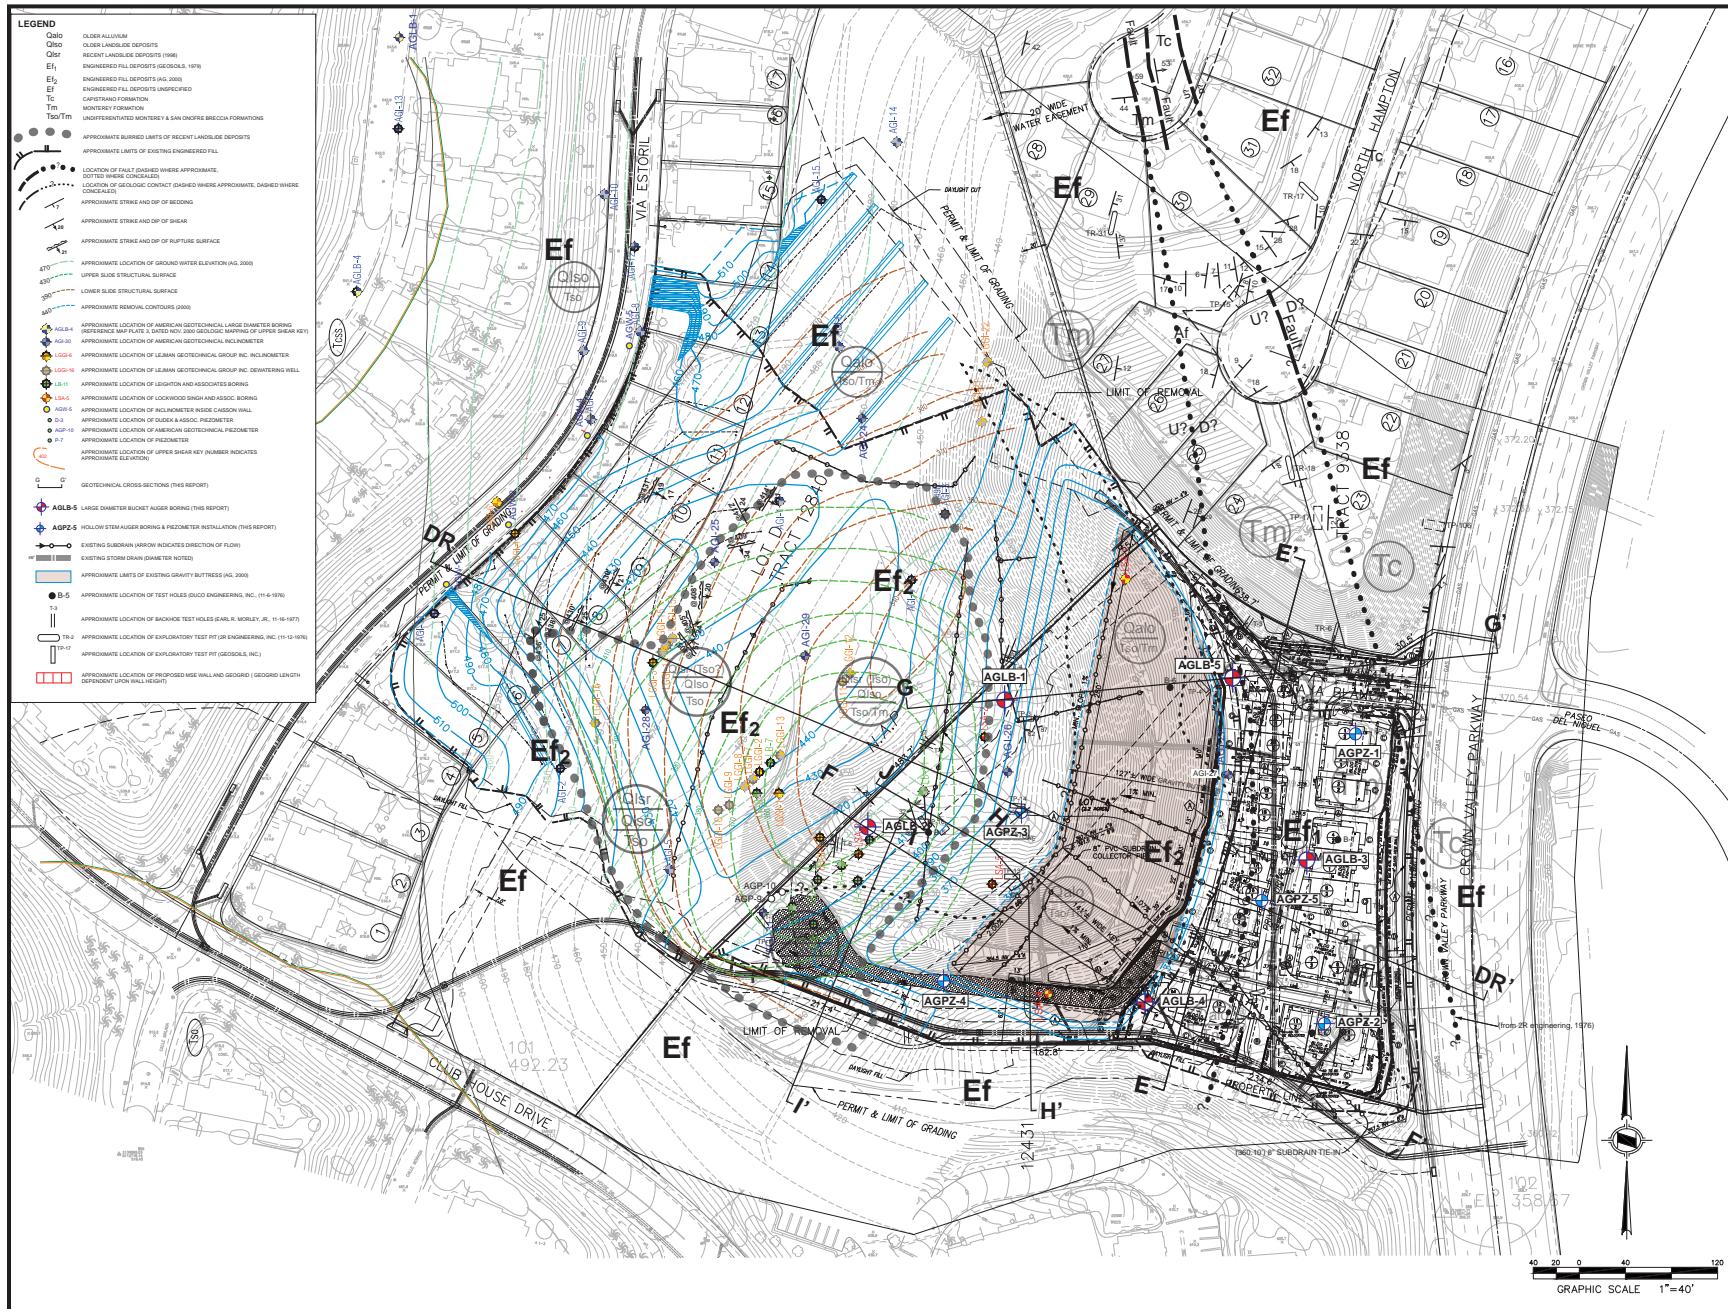
#### Figure 4.6.A Preliminary Geotechnical/Geologic Map

Source: American Geotechnical, Inc. (05/2021).

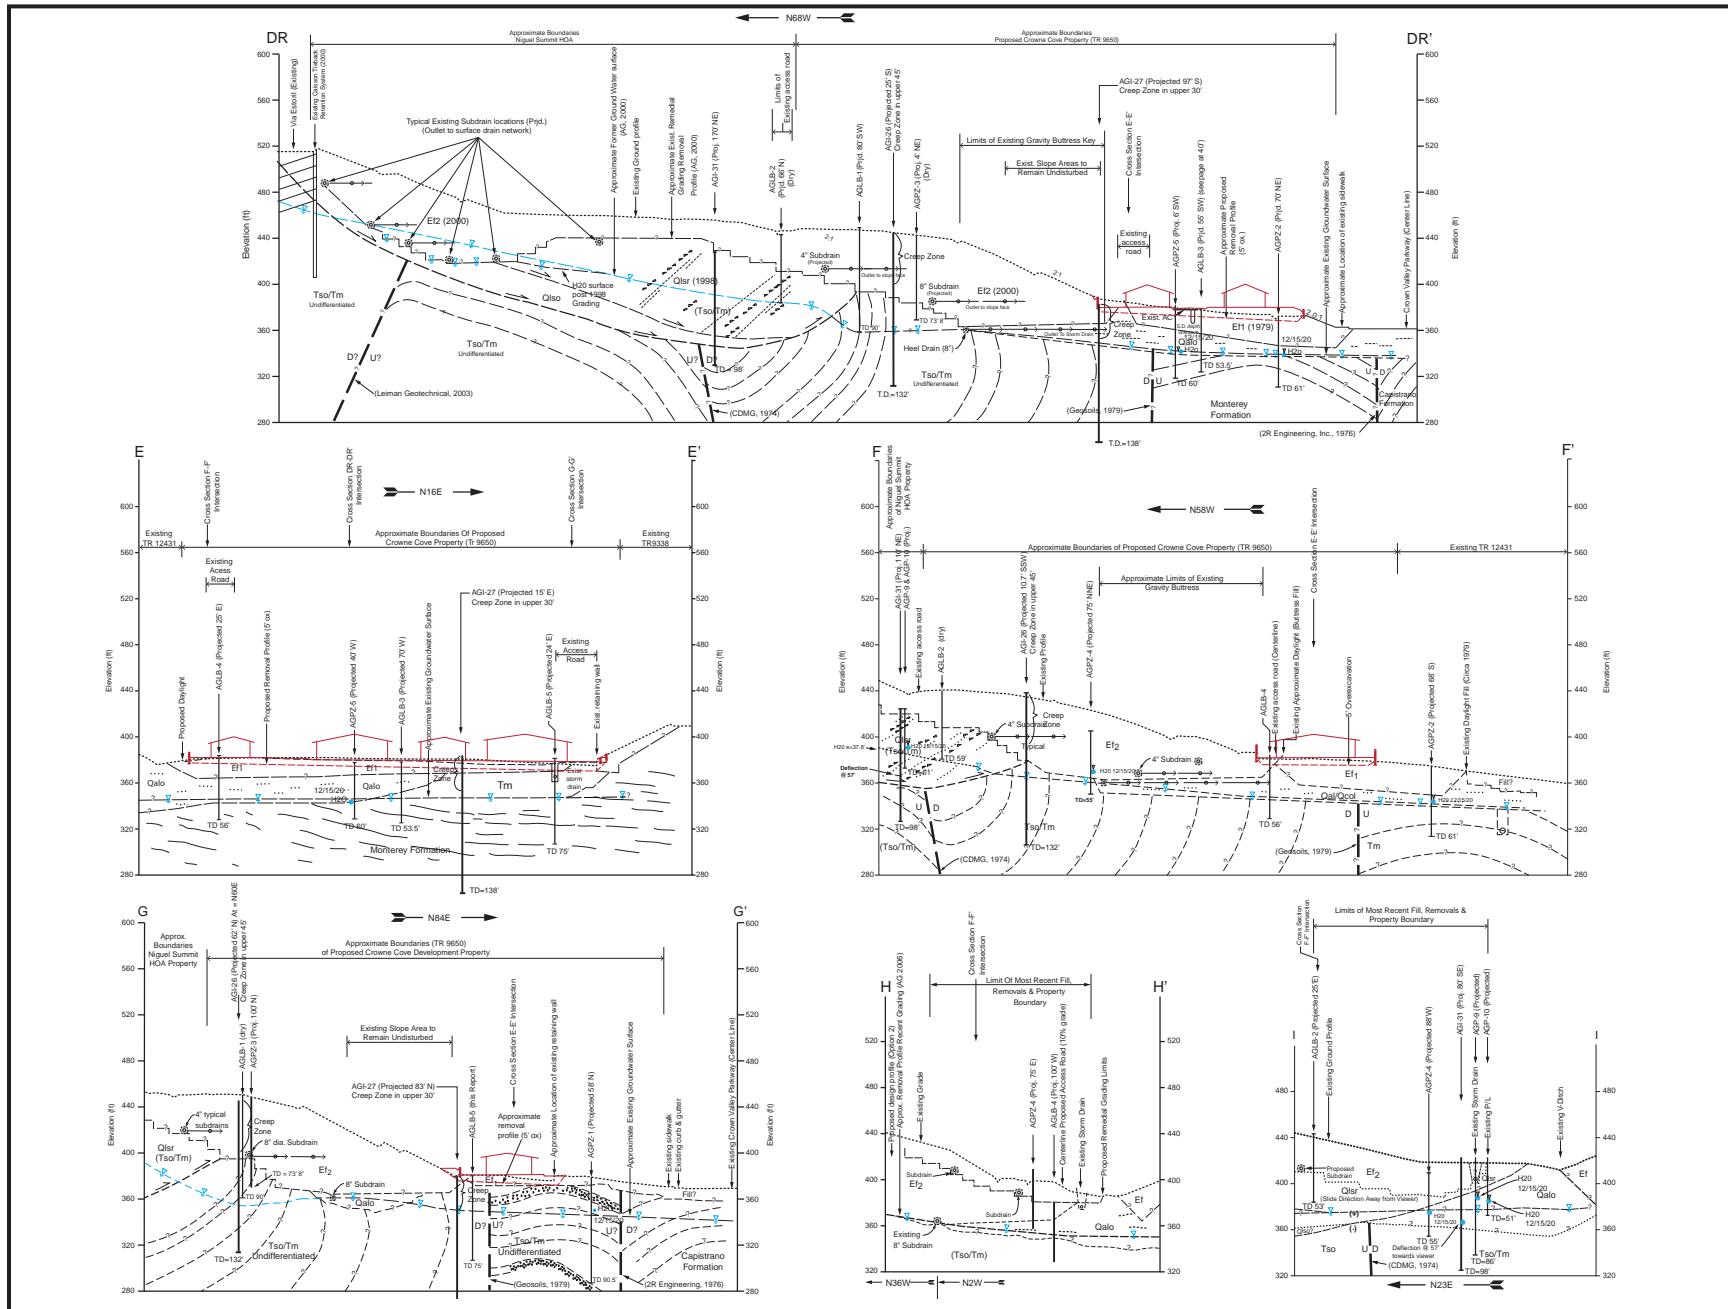
### Figure 4.6.B Geotechnical Cross Sections

Source: American Geotechnical, Inc. (01/2021).

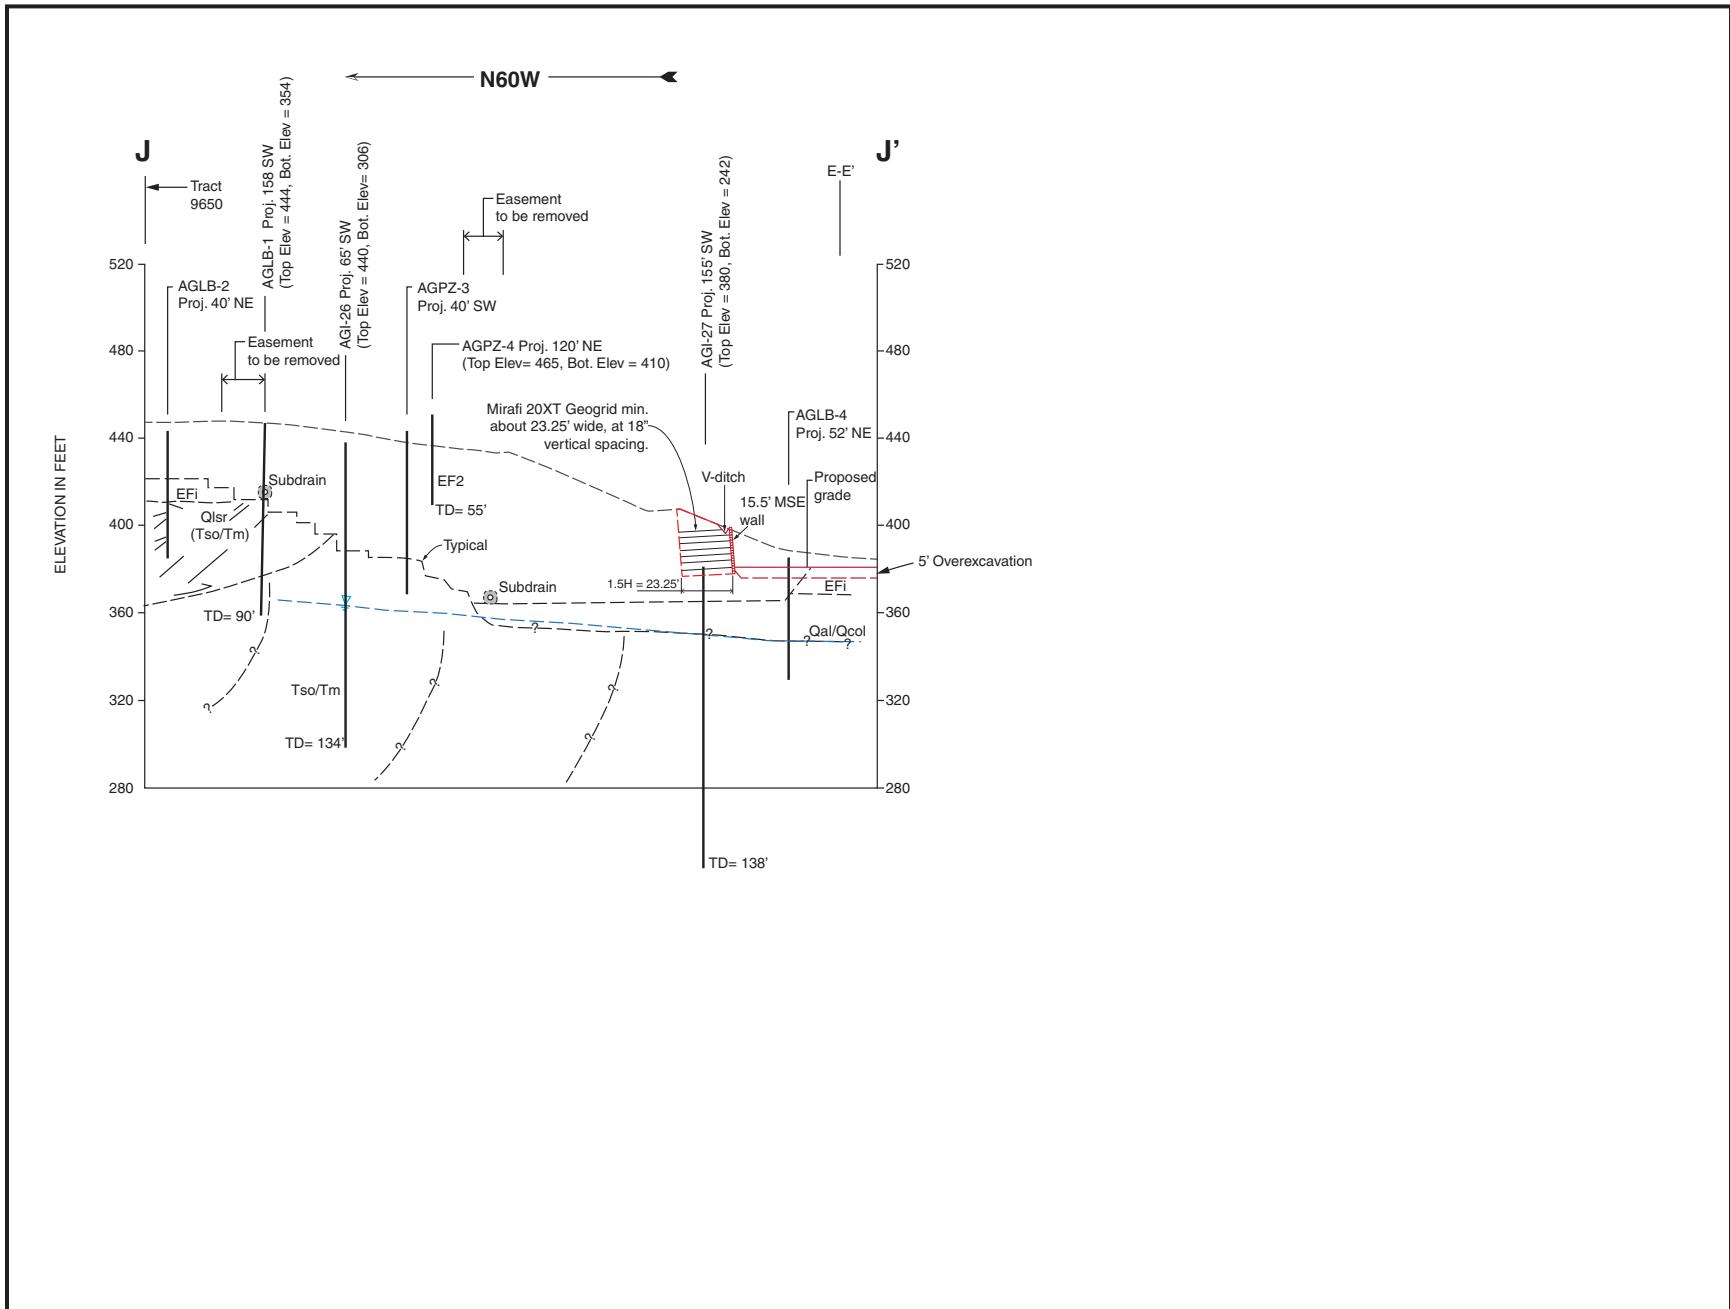
**Figure 4.6.C Geotechnical Cross Section J-J'**

Source: American Geotechnical, Inc. (01/2021).
